Restoration of Historic Qibla Wall - The Holy  
Prophet Mosque- AL-Madinah Al-Munawwarah-  
Kingdom Saudi Arabia

The Centre for Conservation and Restoration of Islamic Architecture Heritage was honoured to be entrusted from Al-Madinah Region Development Authority to prepare a restoration project for the Qibla Wall of the Holy Prophet Mosque with its historic marble and glazed tiles incrustation. The work began on 15<sup>th</sup> of Sept 2019 and was finished with great success on 23<sup>rd</sup> of March 2020.

The work includes the qibla wall incrustation 77.55m long and 2.55m high; 2100 glazed tiles and 126 m<sup>2</sup> marble plates, the Osman bin Affan mihrab as well as the window of Umm Almu'mineen Hafsa, peace be upon Her.

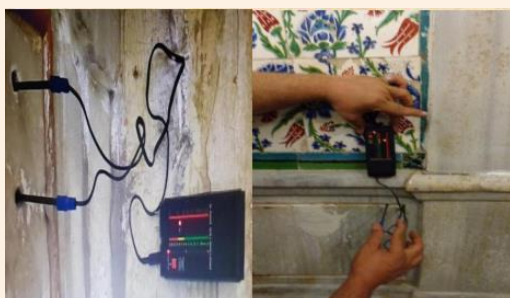
### Dampness in wall

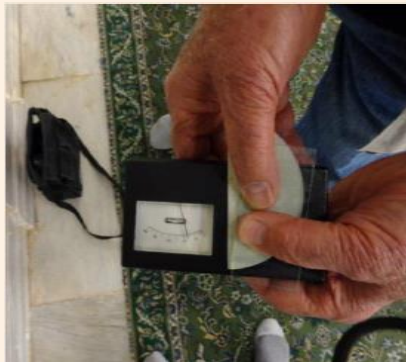
## Hygroscopic salt study and analysis

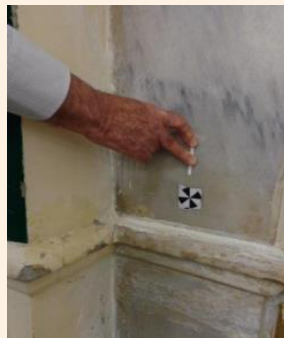
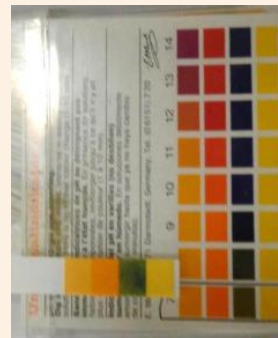
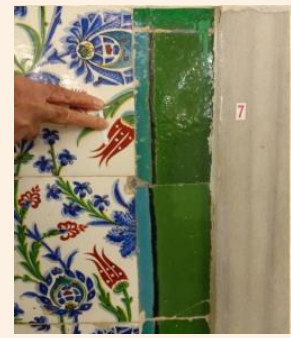
## pH Measurement

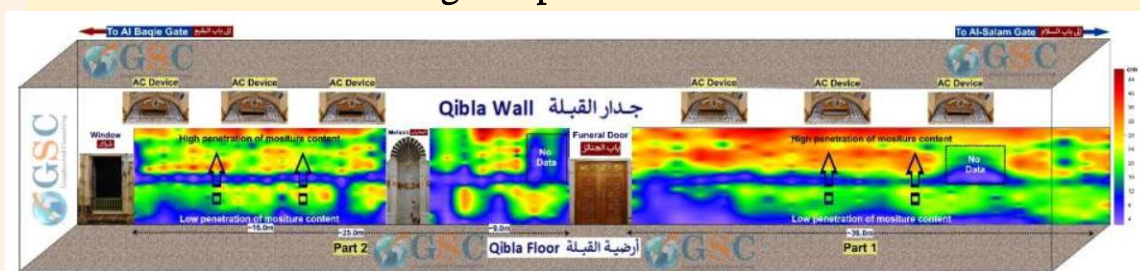
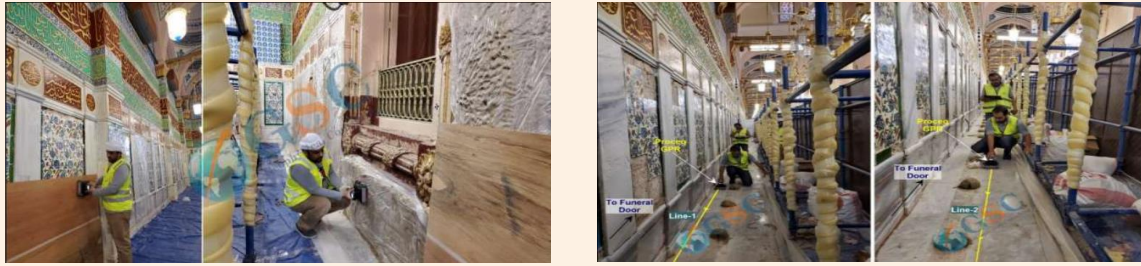
GPR study on wall and floor: (GSC Geophysical Consulting Company)  
checking dampness and its distribution

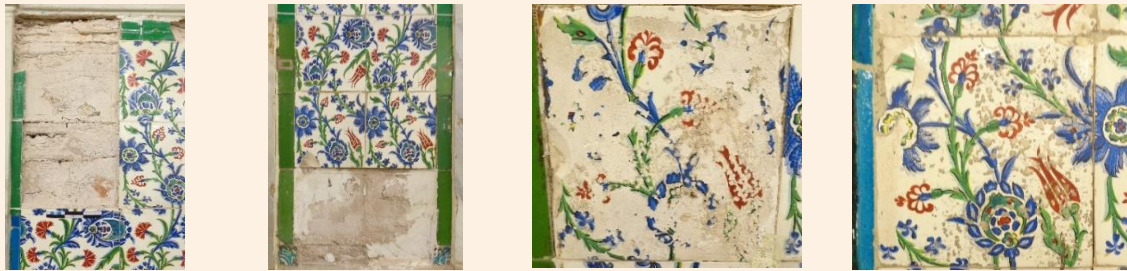
### Missing Part

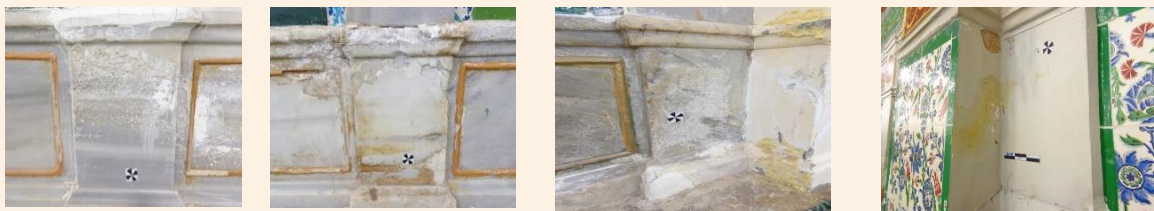
### Dampness

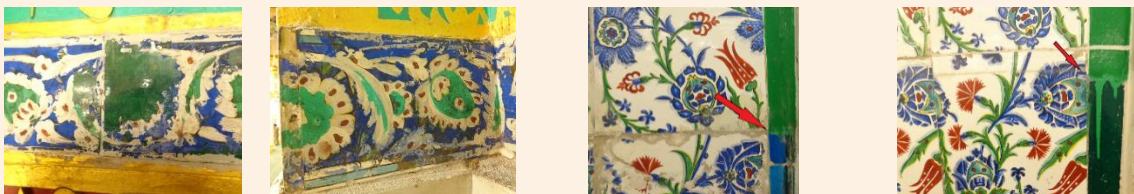
### New Painting

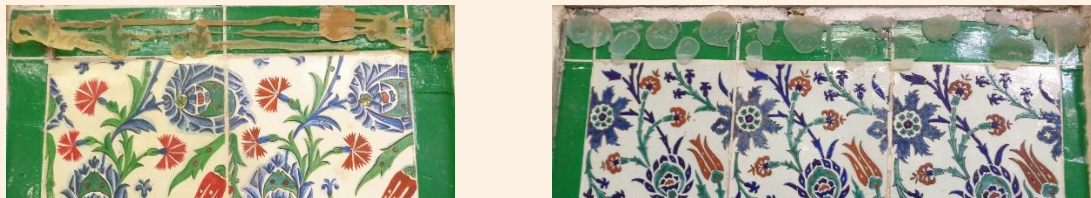
### Silicon Remains

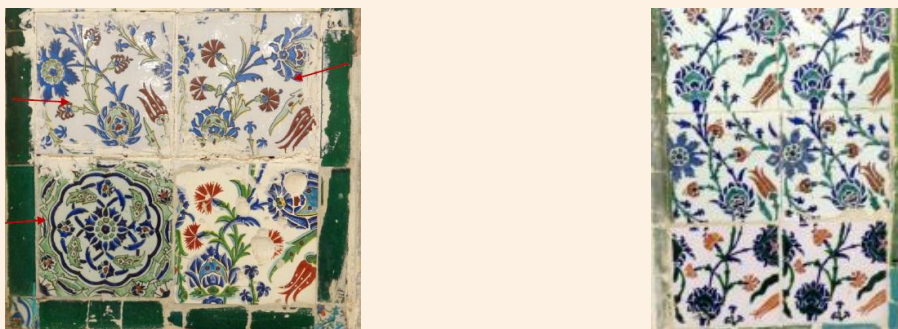
### Wrong completion

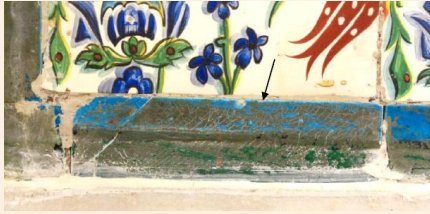
## Surface dirt

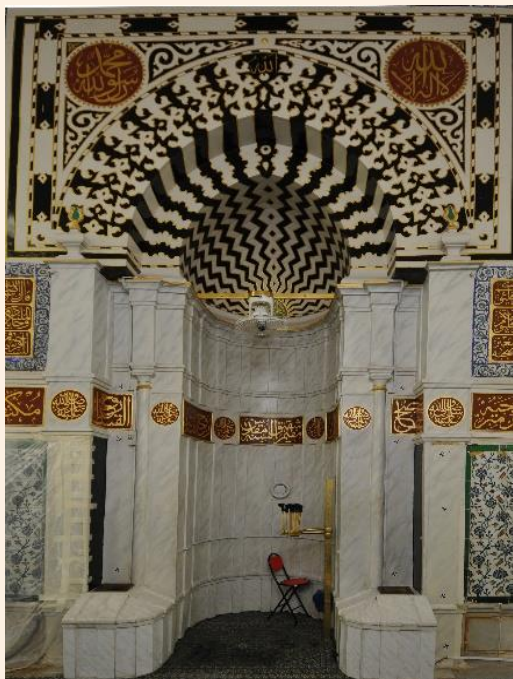
Before Restoration

Conservation and restoration of Mihrab Osman

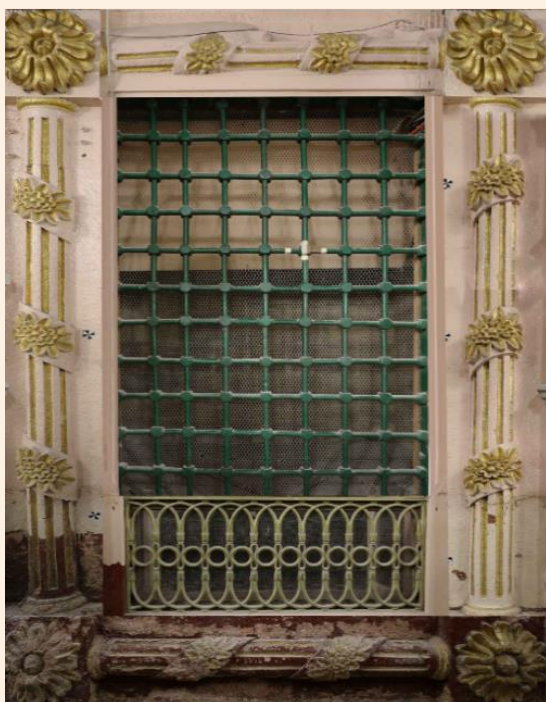
Before Restoration

Complete restoration of lady Hafsa window (stone, carpentary work, brass lattice, decorations and gilding)

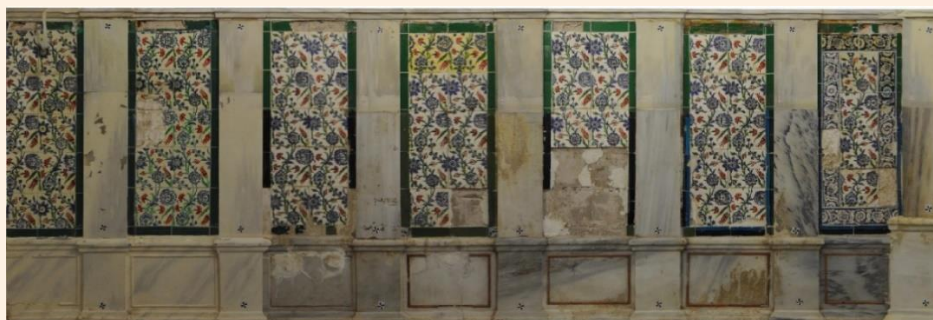
Part of Qibla wall before restoration

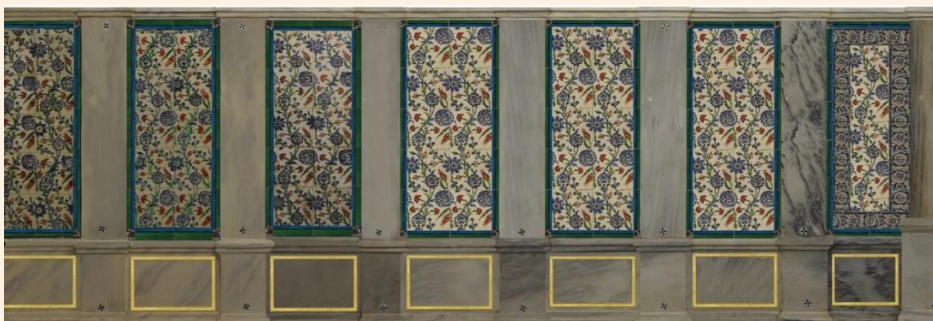
Part of Qibla wall after restoration

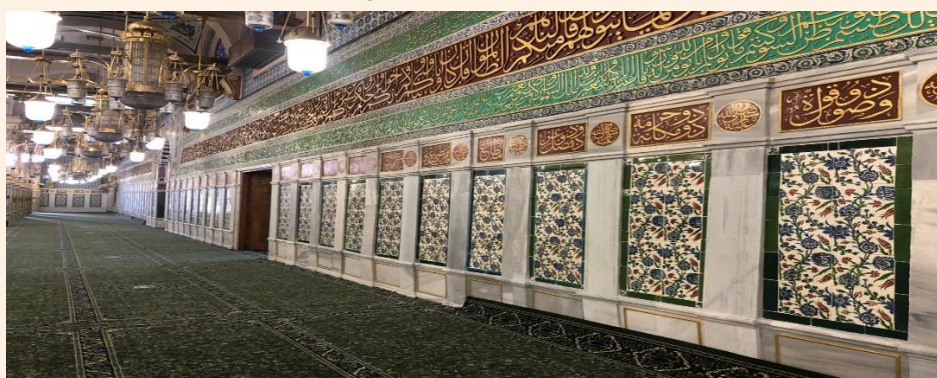
Qibla wall after restoration
