### Message of the President of ISCARSAH Görün Arun

# Rehabilitación estructural del antiguo templo de San Agustín en la Ciudad de México

### Restoring to its original condition and implementing the state-of-the-art technologies

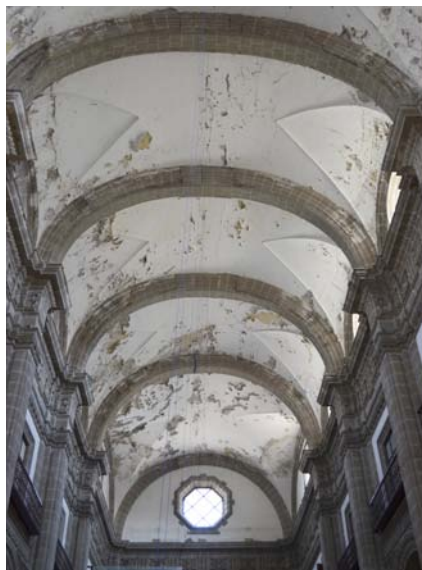
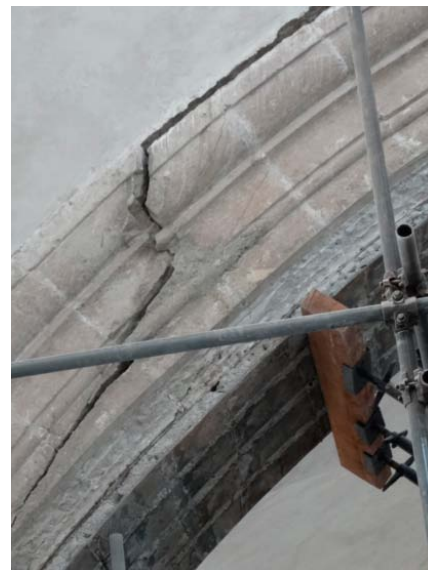
Fracturas y deterioro de mampostería en bóveda y arcos.

Numerosos son los daños locales que se identificaron en otros elementos como arcos botareles, cúpula y lunetos.

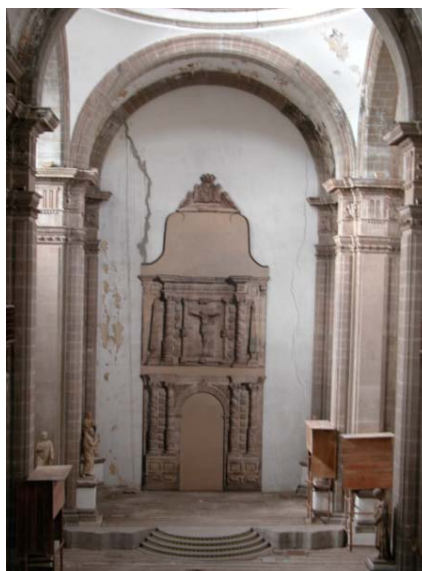
Grietas en muros y columnas.

Las distorsiones de los dos edificios por los asentamientos diferen-

ciales de la cimentación produjeron grandes grietas en columnas y muros.

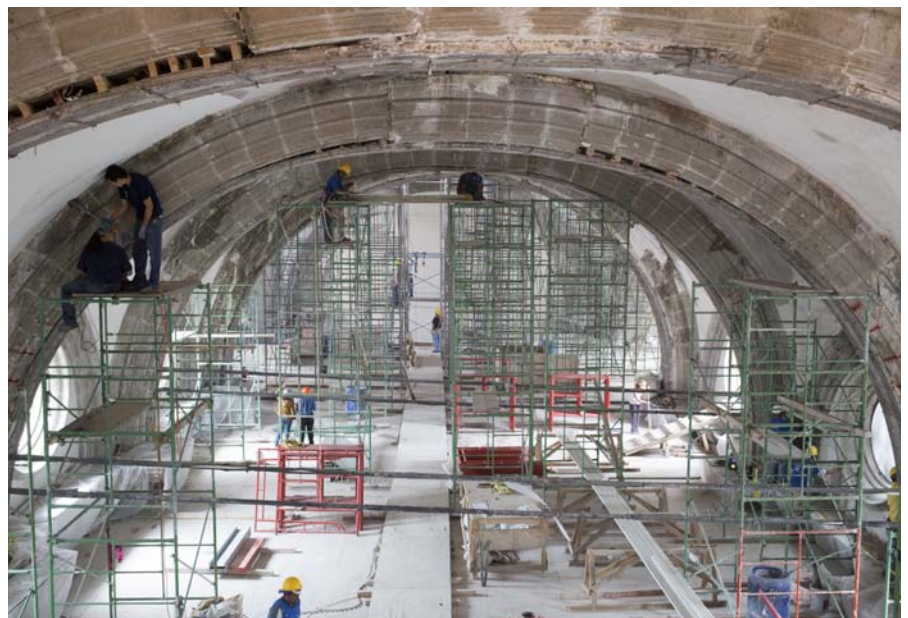
Plataforma de trabajo y andamiaje para la restauración de los arcos y bóveda.

Posteriormente, se instaló una cerrada red de andamios y sobre ella se colocó una plataforma de trabajo a una altura de casi 20 m, a todo lo largo y ancho de la nave, lo que permitió el acceso al intradós de la techumbre, para consolidar la bóveda, restaurar las alfardas y dinteles de ventanas y, sobre todo, para realizar la sustitución de las dovelas fracturadas de los cinco arcos transversales y de los cuatro del crucero.

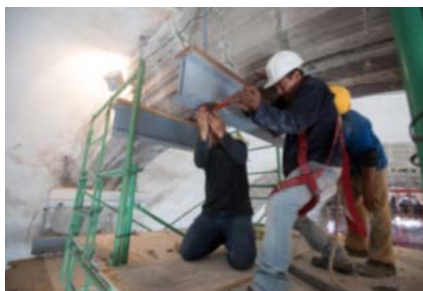
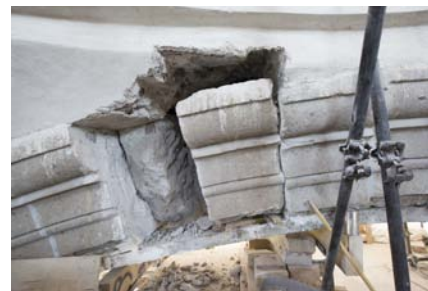
Yugos metálicos para sostén temporal de los arcos y reposición de sillares en dovelas fracturadas.

acero para detener los tramos de arco cercanos a la clave y así poder retirar las piezas fracturadas que componían las dovelas y sustituirlas por nuevas. Cada dovela está formada por dos piezas de aproximadamente 500

kg de peso cada una, que tuvieron que ser elevadas e insertadas en el hueco dejado por la pieza que se había retirado. Posteriormente, se inyectaban las juntas entre sillares. Al concluir el reemplazo de todas las piezas fracturadas se re-

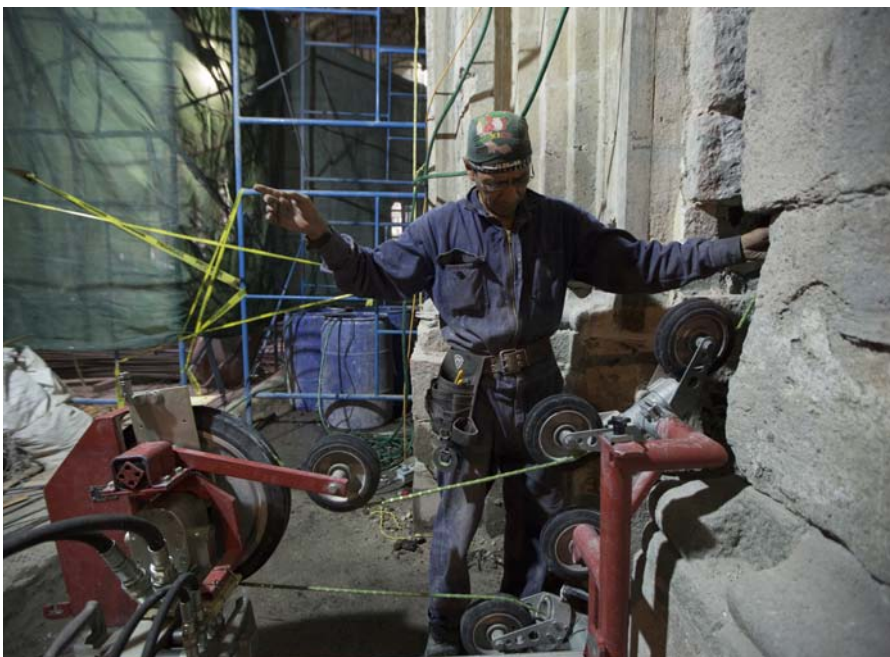
Equipo de corte para abrir una junta de contrucción entre capilla y templo.

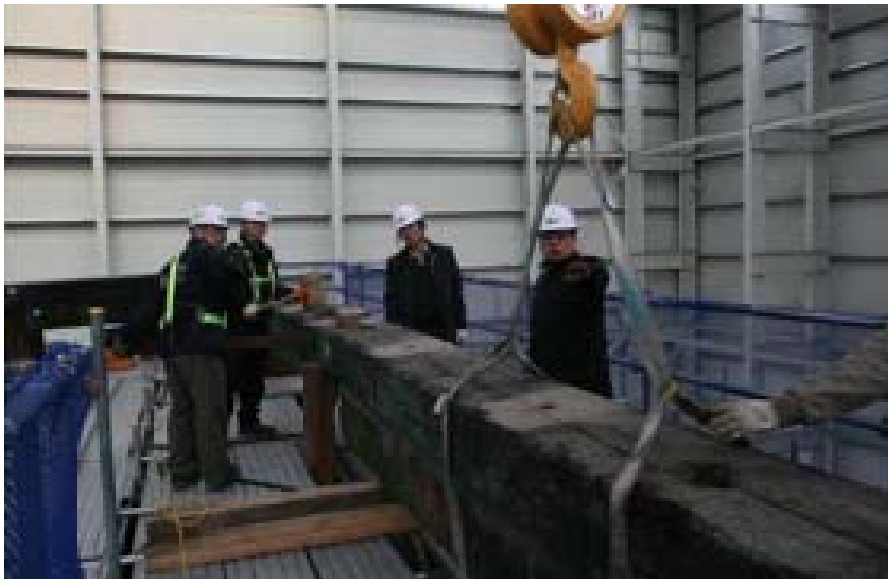
Disassembling the salvaged parts, 2009 (photo: Shin, Eung-Su).

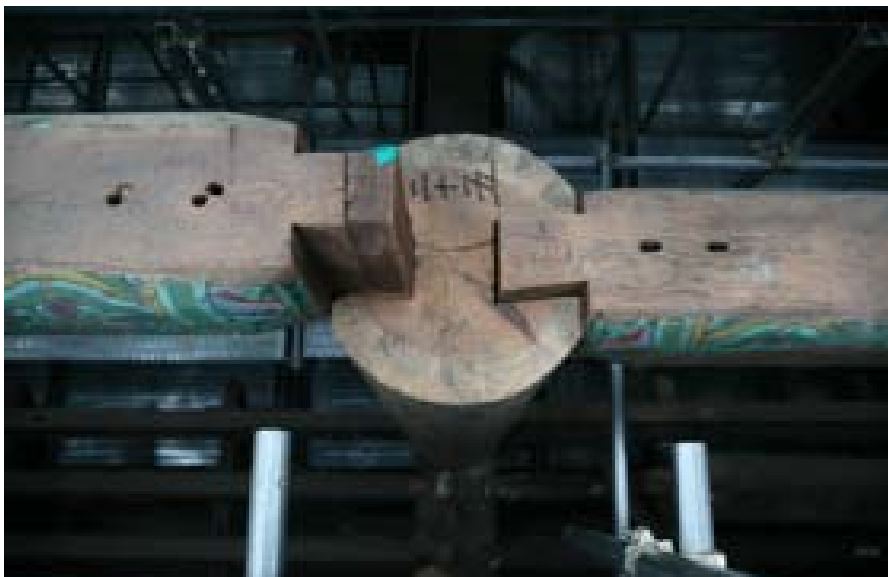
Both the salvaged (connection beam) and new (column) wood were used (photo: Shin, Eung-Su).

Shin insisted on using as much of the salvaged wood as possible; for the remainder, he found locally produced pine over 100 years of age, fashioning it by hand using traditional methods.

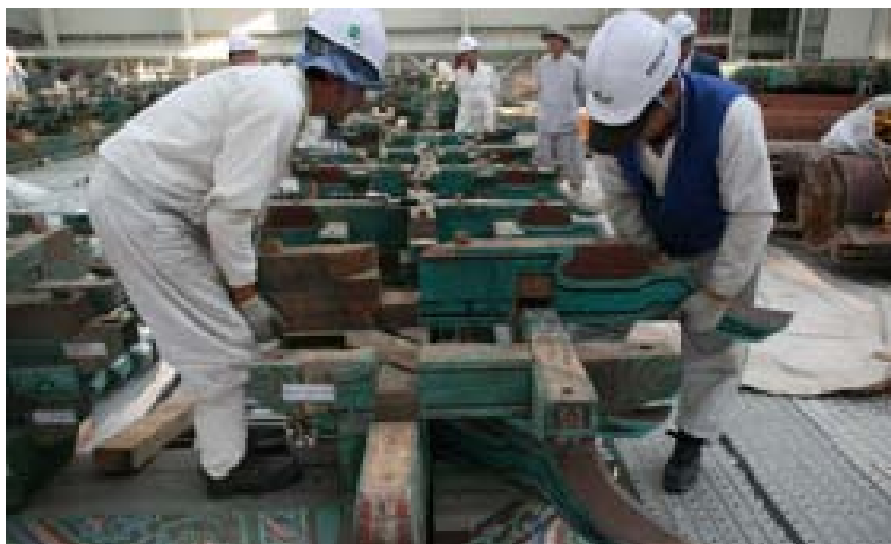
Reassembling the wooden pavilion-lower floor (photo: Shin, Eung-Su).

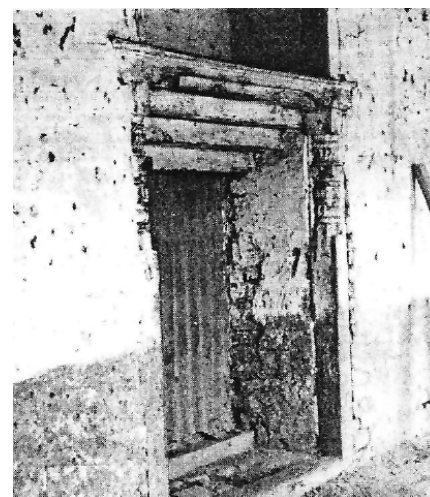
Fig. 5. Rear view of an upper floor window opening. The floor joists and wall plate are visible at the top.

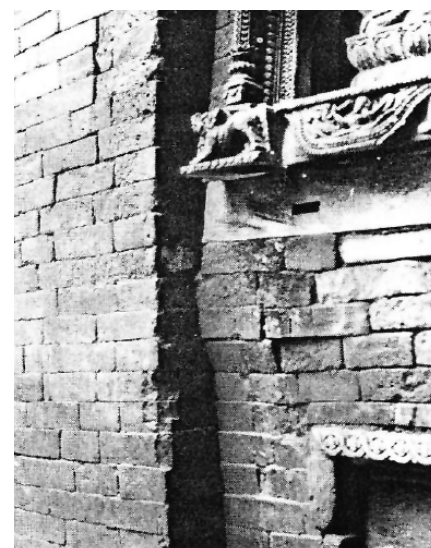
Fig. 7. Local bulging of brickwork beneath a niche. The panel of brickwork on the left is the other end of the panel shown in Fig. 3. The decorative timber of the door sill (lower right) has decayed severely, and the small vertical piece has been replaced with brick tiles.

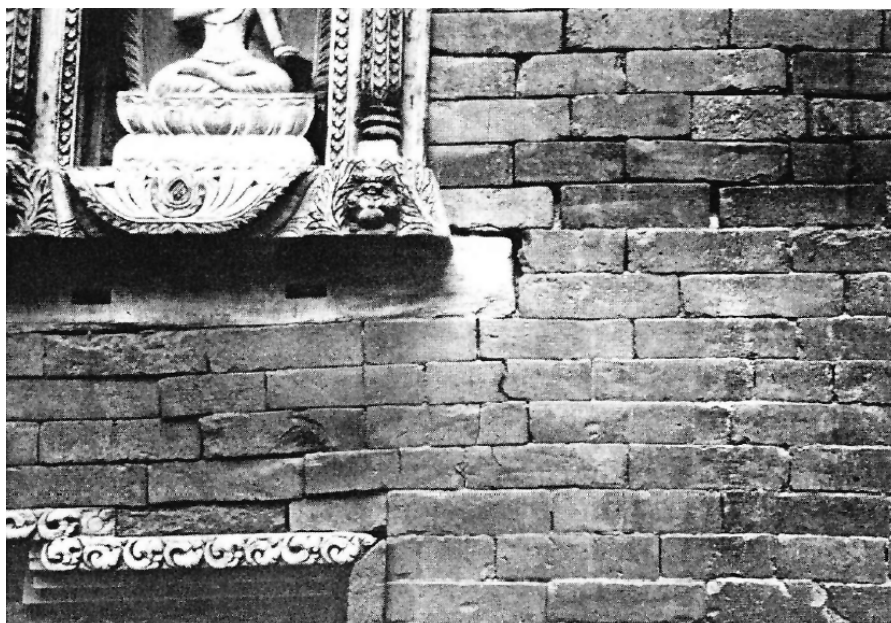
Fig. 8. Variations in brick joints between a niche and a door sill as a result of different compressive forces. This sill has also had timber replaced with brick tile.

Once the mechanism of load transfer into the veneers was established, the condition of the wall was examined to see what parts were carrying load. While the pattern of loading readily apparent in the clear panels of brickwork,

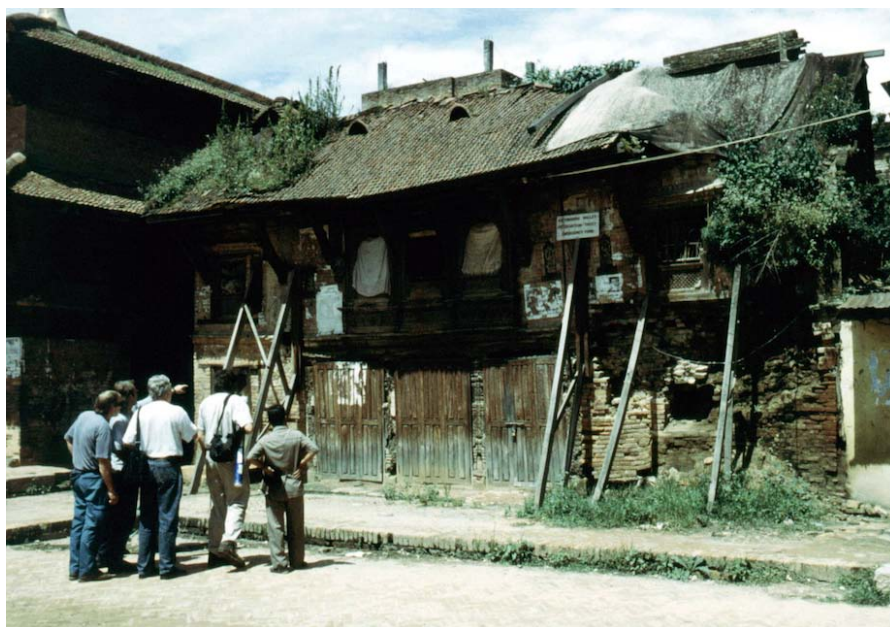
Fig. 9 An example of a building within the Patan Durbar Square Monument Zone which in 1994 was in urgent need of preservation. Photo: Author.
